# Repair of Partially Penetrated Weld Joints in Copper-Nickel Seawater Piping on Naval Ships

Alan A. Rechel

September 2000

The U.S. Navy has experienced several leaks in Cu-Ni seawater piping as a result of partially penetrated welds in the ships' original construction. If it were possible to repair the welds without cutting open the pipe, the Navy could realize significant cost savings on ship repair. This investigation evaluated whether it would be possible to achieve satisfactory weld repairs by remelting the weld zone, fusing the joint through its full thickness without cleaning the interior of the pipe.

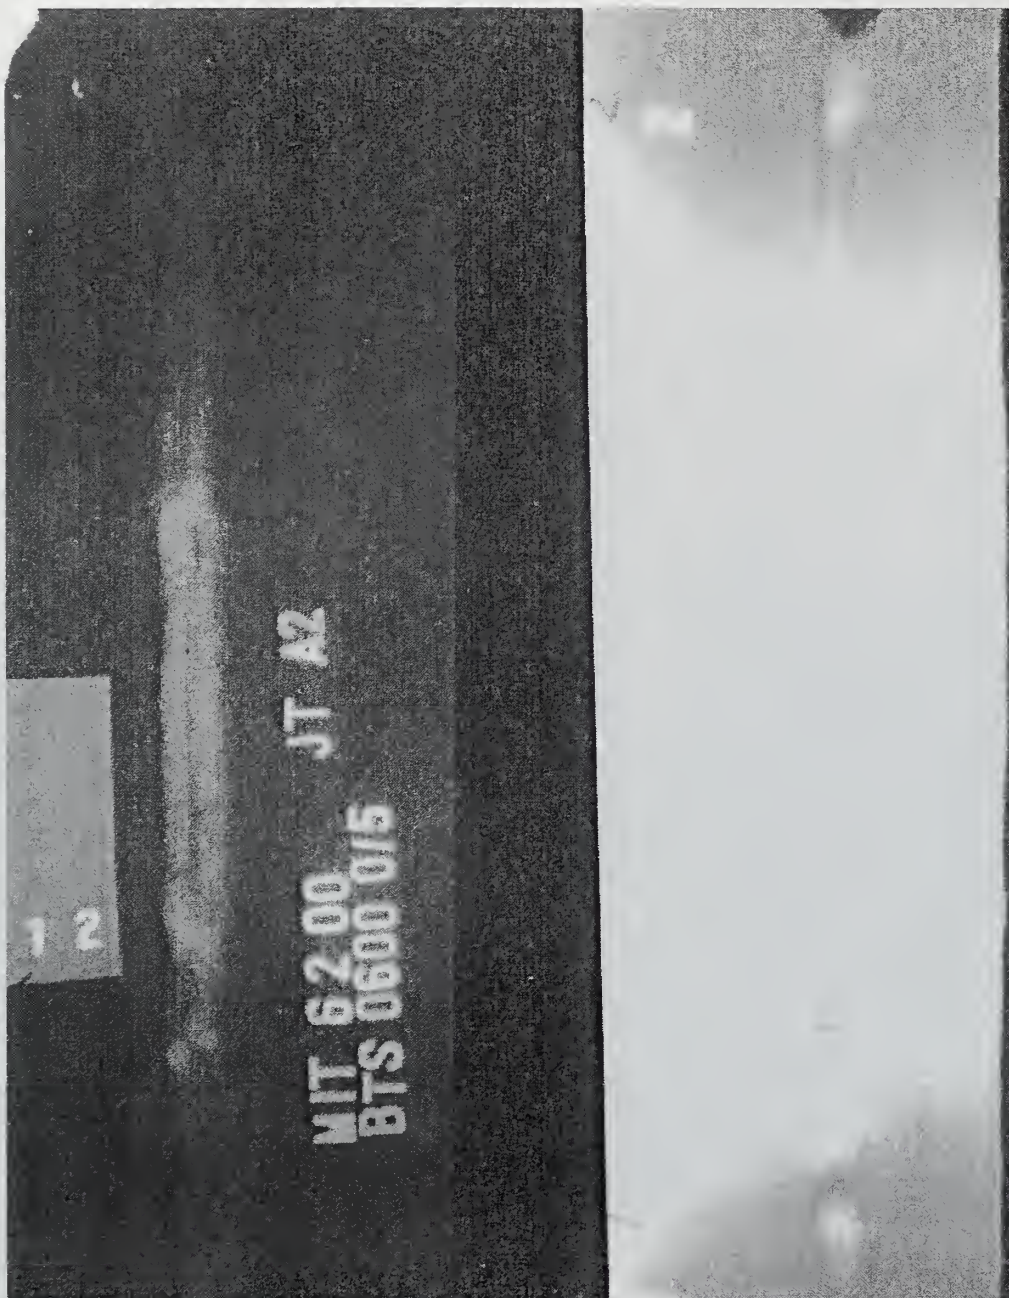
Figure 4-21: Close-up of Weld A2, Section 1-2

on the individual welder's proficiency. Figures 4-21 through 4-24 show close-ups of the X-rays showing locations where the repair weld did indeed fill the flawed weld. Figures 4-25 through 4-27 are photographs of the root surface of effectively repaired welds, cleaned of scale. The black lines show where the partial penetration had been; the arrows indicate the extent of the full penetration. The protruding bead has filled the crevice.
